Root Area Transition Zone – RATZ and Reduction O&M cost of WT blades

EUDP project 64015-0602 – Final Report

Date: 22-03-2019

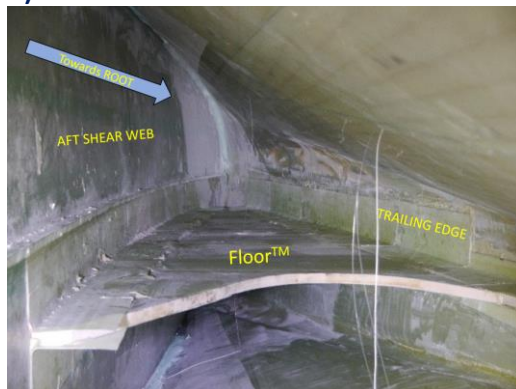
C) Floor™ installed in an LM58.7m blade.

Figure 2: A) The Bladena Floor™ technology works as a horizontal shear web installed between the aft shear web and the trailing edge on the Root-Transition zone of a wind turbine blade. B) Floor™ is retrofitted in an SSP34m blade. It can be seen how the aft shear web spans out and connects with the trailing edge/blade root. C) Floor™ is retrofitted in an LM58.7m blade. The retrofitted Floors™ in the SSP34m blade and the LM58.7m blade are used for demonstration purposes in the RATZ project [4] [5] [6].

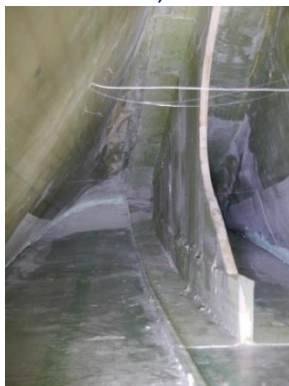
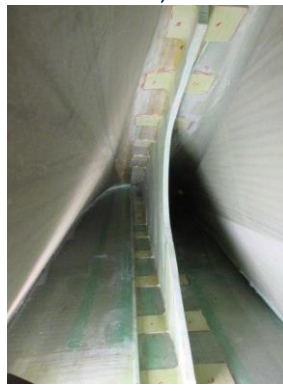
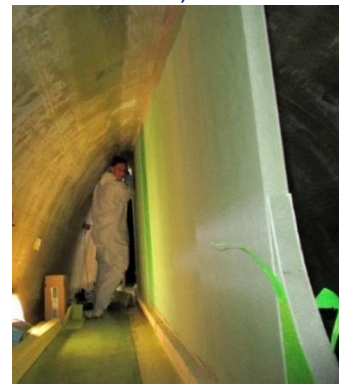
A) Floor™ prototype #1
SSP34m blade, Blaest

B) Floor™ prototype #2
SSP34m blade, DTU

C) Floor™ prototype #3
LM58.7m blade, Blaest

Figure 12: A) and B) Prototype #1 and #2 are both designed to be retrofitted in a SSP34m blade. For each prototype, experience is gathered and used in the design for the next prototype. C) The Floor™ prototype are retrofitted in the LM58.7m blade which are almost twice as long as the SSP34m blade.

The Floor™ product was originally meant to be a part of new-designs for large wind turbine blades. In the RAZZ project the tested Floors™ have been designed essentially as retrofit solutions. The Floor™ designs have been supported by FEM simulations and retrofitted in two SSP34m blades and one LM58.7m blade, see Figure 12.

Three Floors™ has been designed, retrofitted in blades and tested in fatigue during the RAZZ project. The largest Floor™ was 6m long and installed in the LM58.7m blade, see Figure 12c and Figure 13.

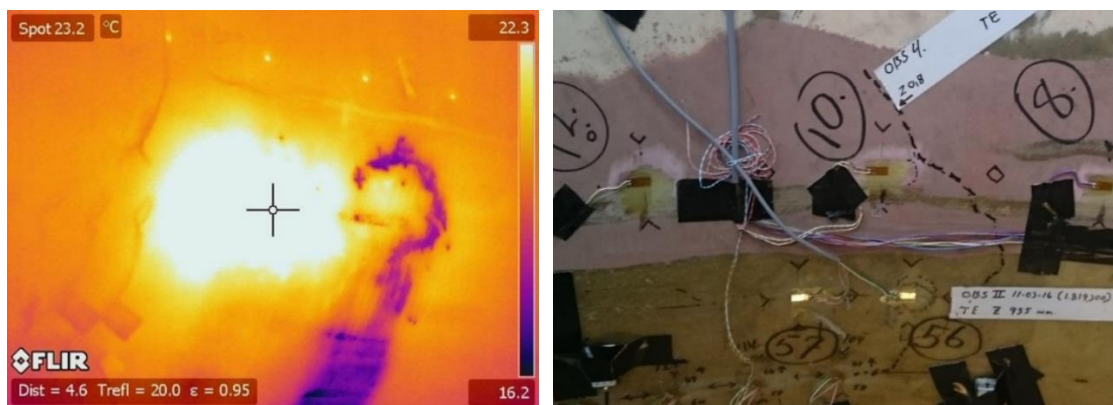
Figure 17: NDT (Ultrasound) inspection was used to detect the size of the damage in the Root-Transition zone of the SSP34m blade.

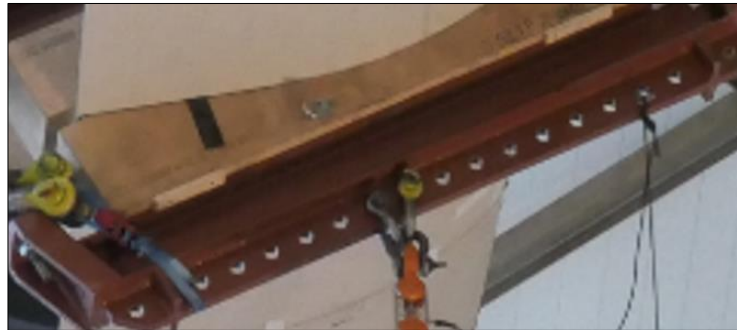
Original load application:

Clamps/forces only applied on the outer 40% of the blade permitting the inner 60% to move freely in terms of local deformations as breathing, panel bending and cross-sectional distortion in shear - called Cross Sectional Shear Distortion (CSSD). Furthermore, buckling of the trailing edge must be changed when clamps are supporting the trailing edge. By only having the clamps placed in the outer region, they do not “disturb” the midspan area, where buckling usually is most critical. In Figure 29 the clamps are shown in two different load configurations. The two different positions are used in order to introduce torsion to the blade, which is expected to affect the overall deformational behavior of the blade, both in terms of breathing and CSSD.

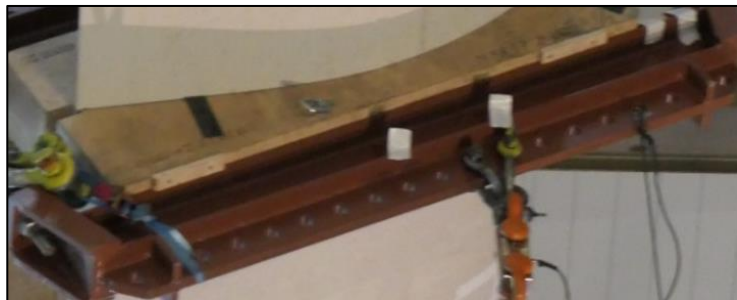
Figure 29: The same test was performed with and without and offset of the load application point towards trailing edge. In the figure is shown the wooden clamp at 49m from blade root with the two different load applications.

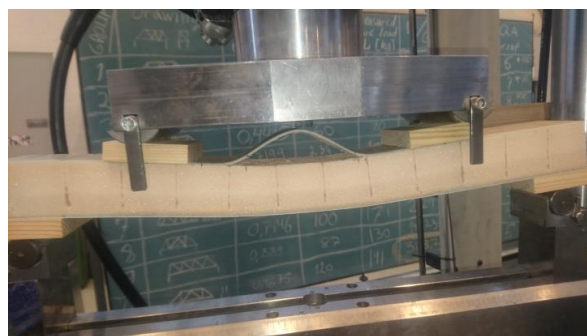
Figure 37: Detail of the face buckling under compressive state loading. This is phenomenon additionally lowers the bending stiffness of the setup

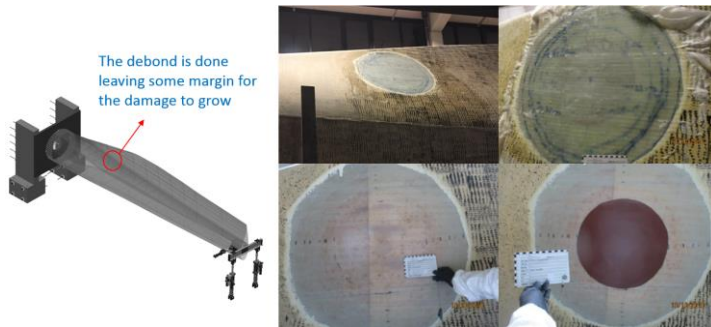
Figure 39: Debonded skin setup in SSP34 blade installed at DTU. On the right, a detail of the defect manufacturing highlighting the size of the defect introduced.

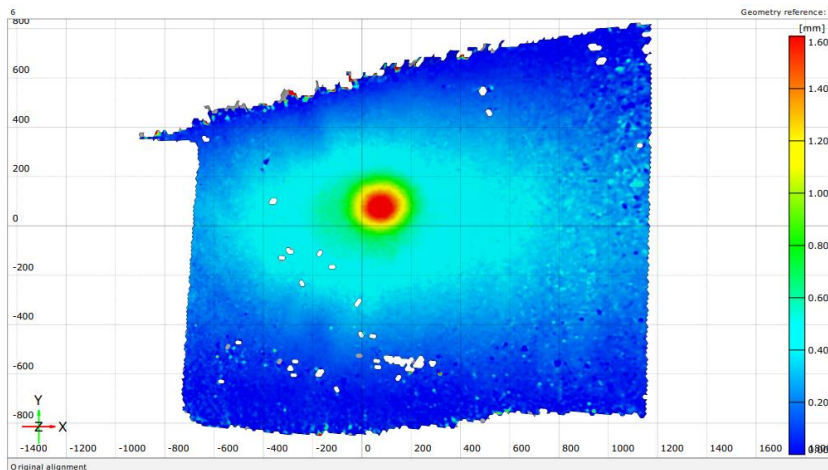
Figure 41: Surface contour plot of the out of plane deformation of the debonded area using Digital Image Correlation technique. The load applied on the backside of the top face shows the presence of a delaminated zone, although the precise extent of it is not clearly defined.

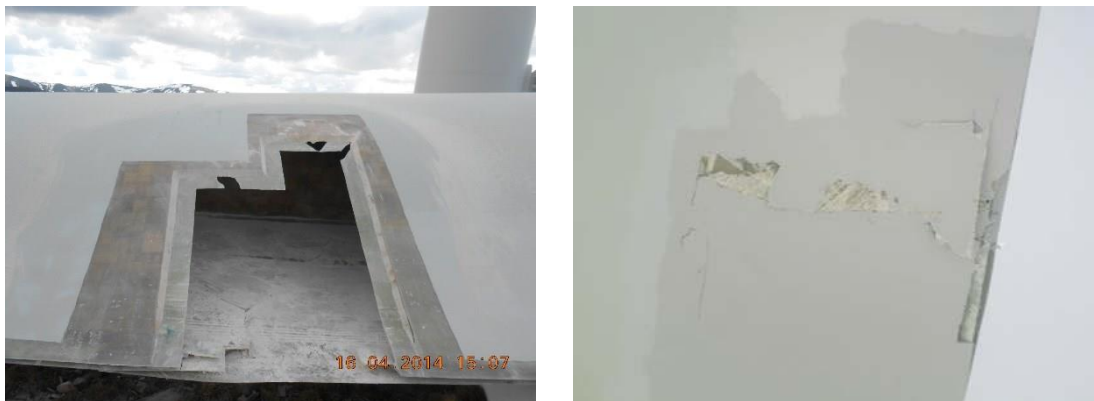
Figure 55: Extract of a blade inspection report showing transverse cracks in the max chord region on an infield wind turbine blade.

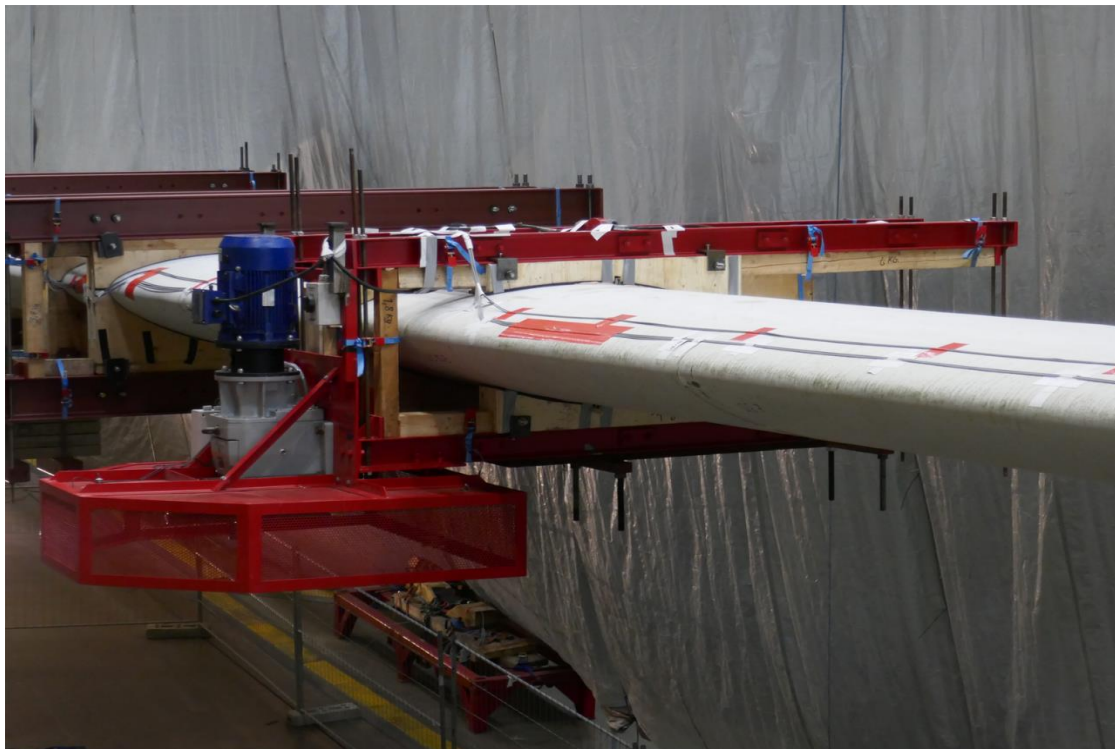
Figure 69: Full scale fatigue test. The clamps are mounted on the different sections of the blade to apply the appropriate load.

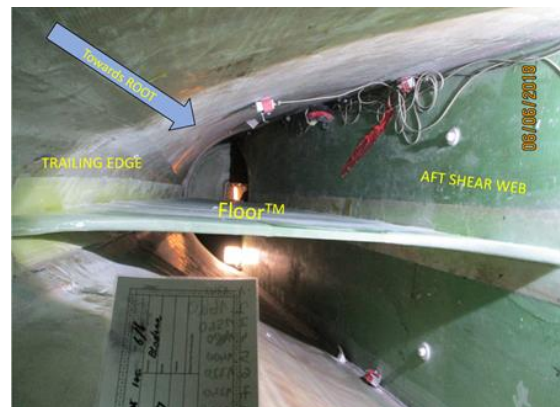
Figure 72: The Floor™ is designed to be retrofitted in the Root-transition zone of a wind turbine area between the aft shear web and the trailing edge. Here can be seen the first prototype of a Floor™ retrofitted in the LM58.7m blade.

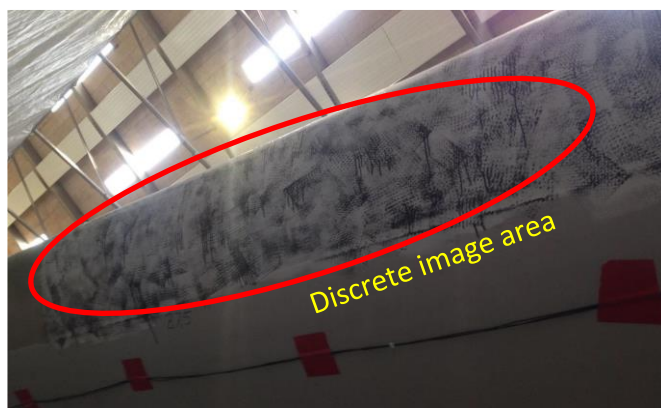
The transition zone area was selected between pressure and suction side with a width of approximately 1.2m as visualized in Figure 88. Similar to the max chord area, the painted area was converted into a canvas with respect to the longitudinal and transverse paths of the desired area.

Figure 88: Transition area representation.

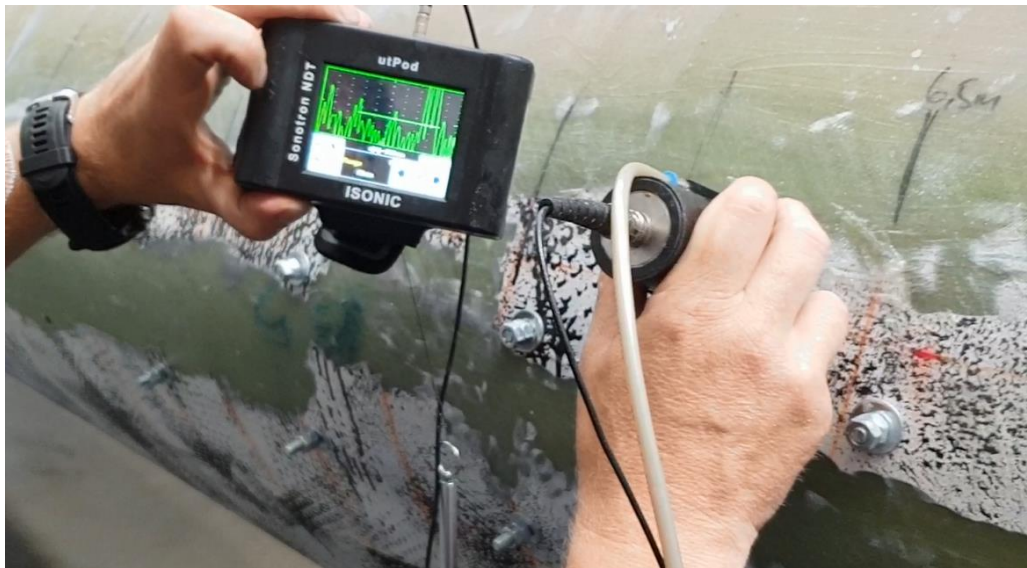
Figure 97: Damage detected

1. Indications (lamination or crushed) were found between 6.1m to 6.35m and 7.5m to 7.85m. This was approximately the same on both examination dates.
2. There has been very limited variation of the indications found between the measurements, and any potential growth is within the uncertainty of manual measurements.

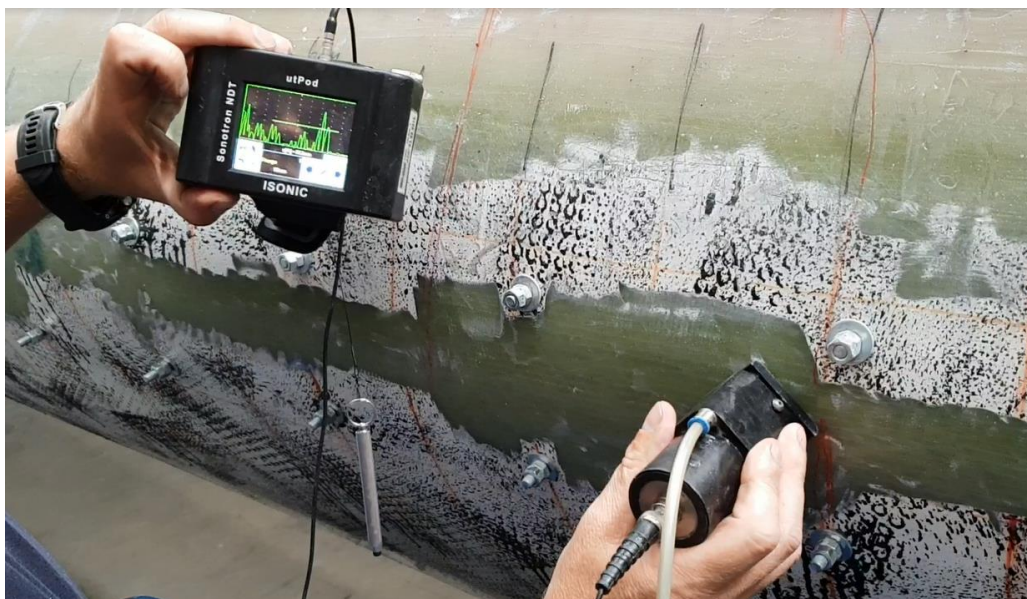
Figure 98: No damage

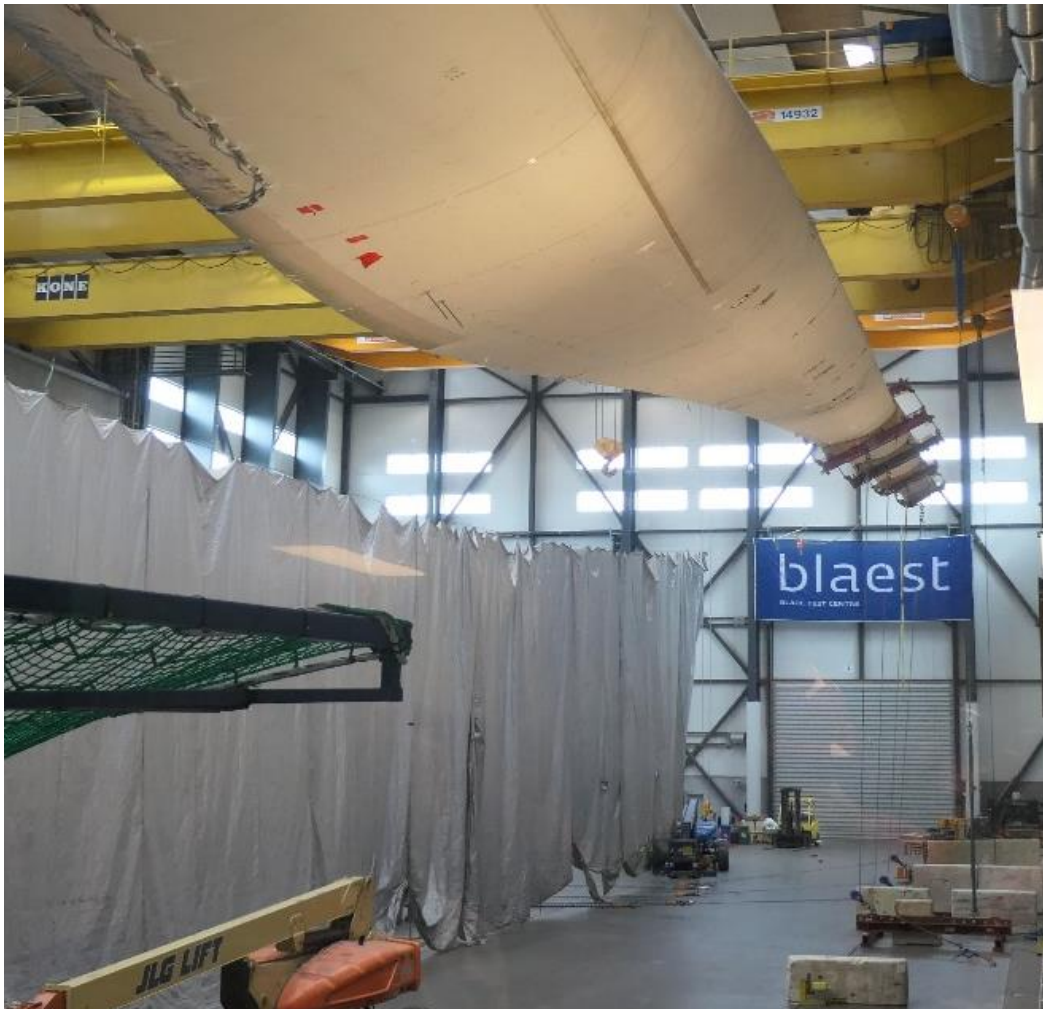
Figure 102: The LM58.7m blade is fixed at the root and hanging angled to ensure that the test pull towards the floor is in the right direction (combined load) according to the blade. Four clamps have been distributed in the outer 40% of the blade to apply the load.

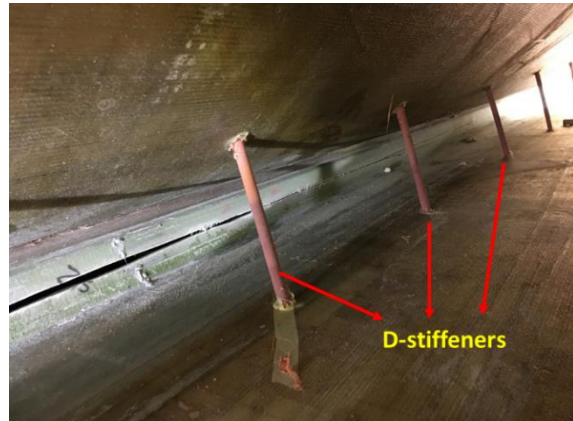
Subfigure 2b: D-stiffeners

Figure 103: D-stiffeners and C-web visualization

This chapter gives a short description of the test conditions and load configurations. As already mentioned, the blade was imposed in four different static tests. At first, C-web was used as reinforcement type. Secondly, the C-web was removed, and D-stiffeners were installed along the midspan area, while for the final two tests, both reinforcements have been removed. In figures 2a and 2b, C-web and D-stiffener are illustrated respectively.

Finally, the D-stiffeners were installed at specific positions along the midspan area starting at 9.4m from the blade root and until 24m. With respect to every section, the D-stiffeners were placed at specific locations from the trailing edge. Each one of these positions are presented in Table 11.

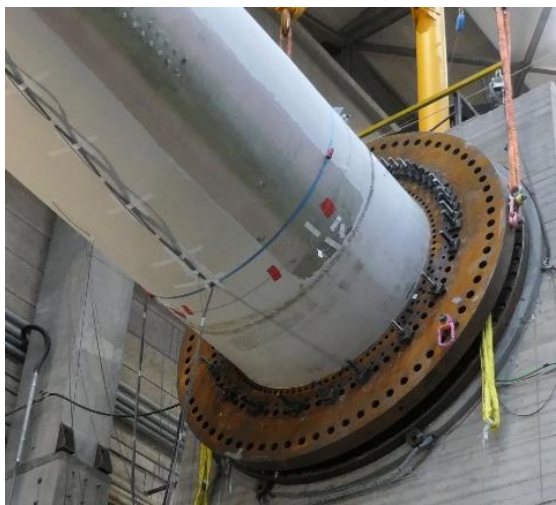
For the combined load test, the blade was mounted on the test rig as shown in Subfigure 4a. The load configuration included wooden clamps, designed accordingly to the respective section of the blade. Finally, steel panels were used around the wooden clamps, in order to attach a steel wire and apply the desired force for every section individually. In Subfigure 4c, it can be observed the entire experiment configuration with the steel wires and how these apply forces to the respective blade sections. Moreover, Subfigure 4b depicts the applied forces as these are imposed to the different sections. For simplicity reasons, for the rest of this report the clamps where the load is applied will be called as “Clamp 1”, “Clamp 2”, “Clamp 3”, “Clamp 4” starting at the tip of the blade and towards the root.

Subfigure 4a: Mounting of the blade

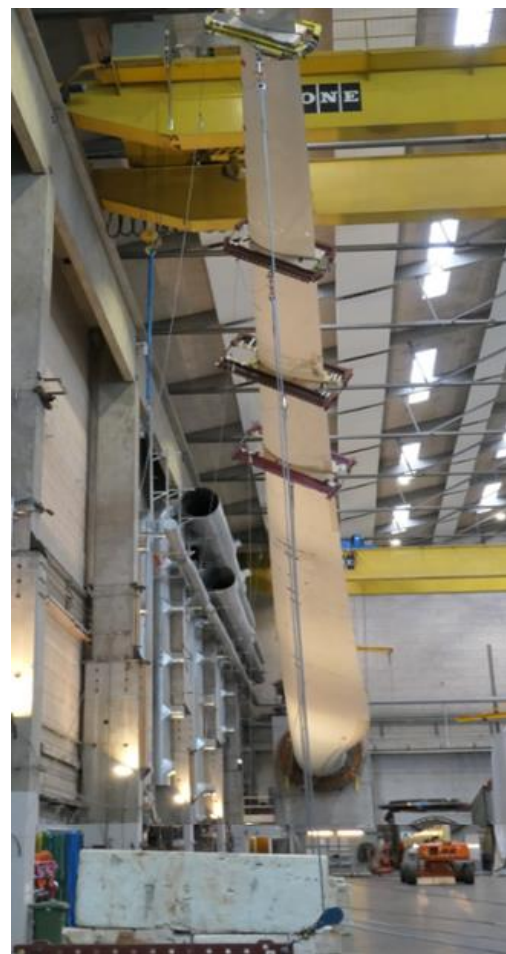
Subfigure 4c: Experiment configuration

Figure 105: Experiment setup

Finally, all the forces were applied through steel wires (Figure 105c) that were connected to clamps at specified sections of the blade. However, because the usage of clamps restricts the local deformation, all the forces were applied at the 40% of the blade length towards the tip, while the rest of the blade was free of clamps in order to capture any local deformations. The acting forces with respect to the length of the blade is illustrated in Figure 106, while the exact force magnitude and location are presented in Table 12.

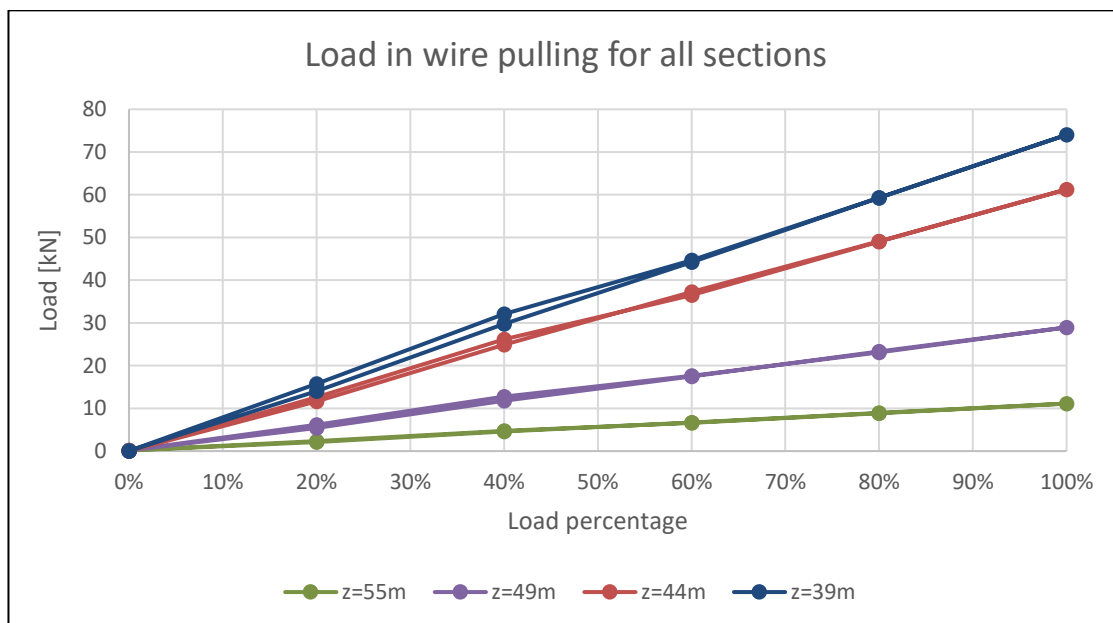
Figure 108: Load in wire pulling for every section of applied force

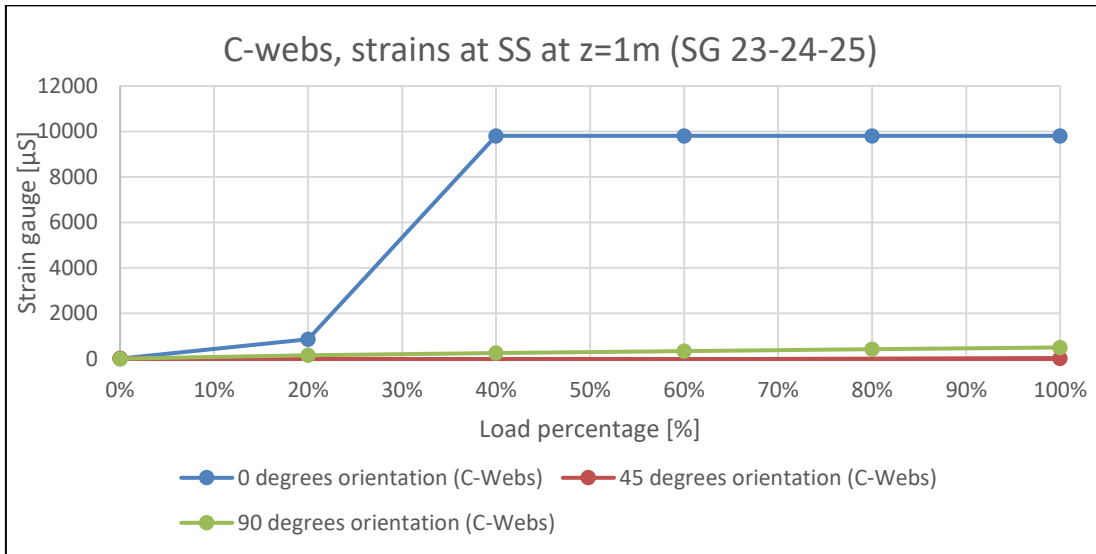
Figure 147: Tri-axial strain gauges at suction side in case of C-webs

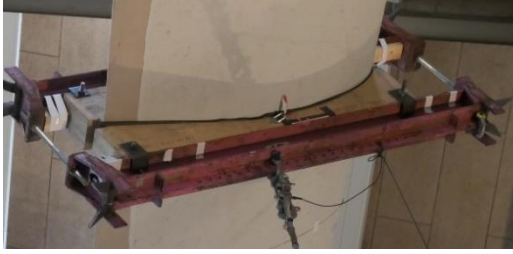
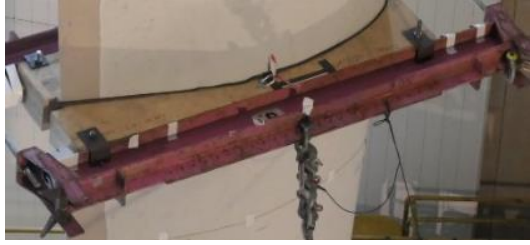
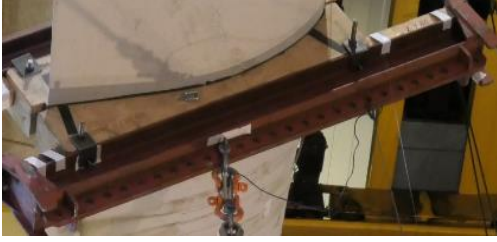
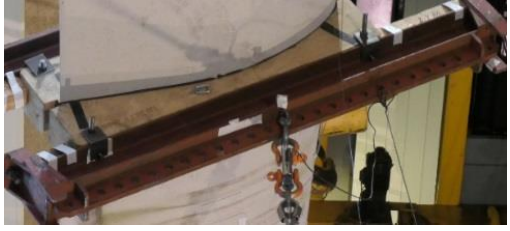
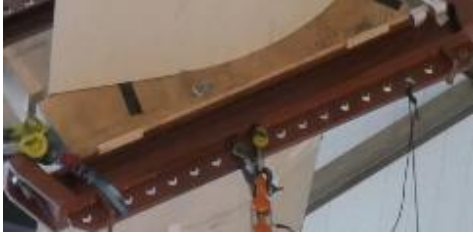
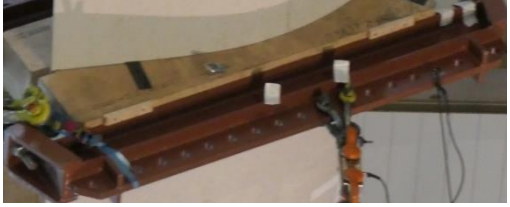
Table 17: Load offset positions

Original position	Offset position
Z=39m

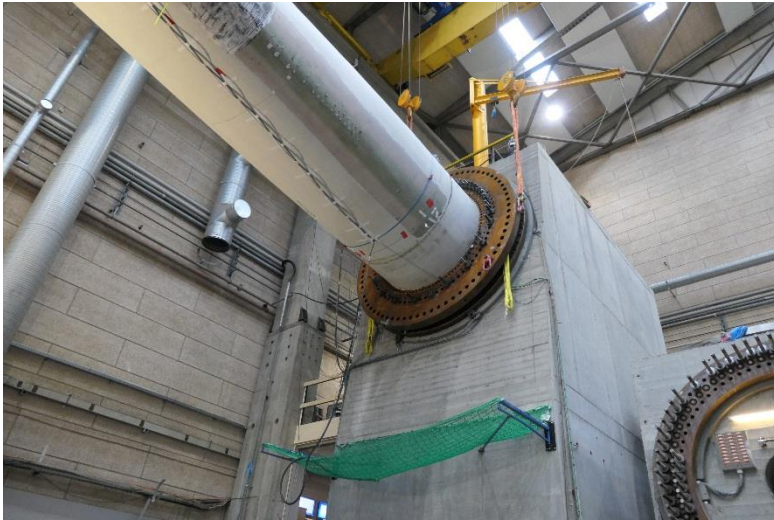
Figure 173: Blade root mounted on the test rig

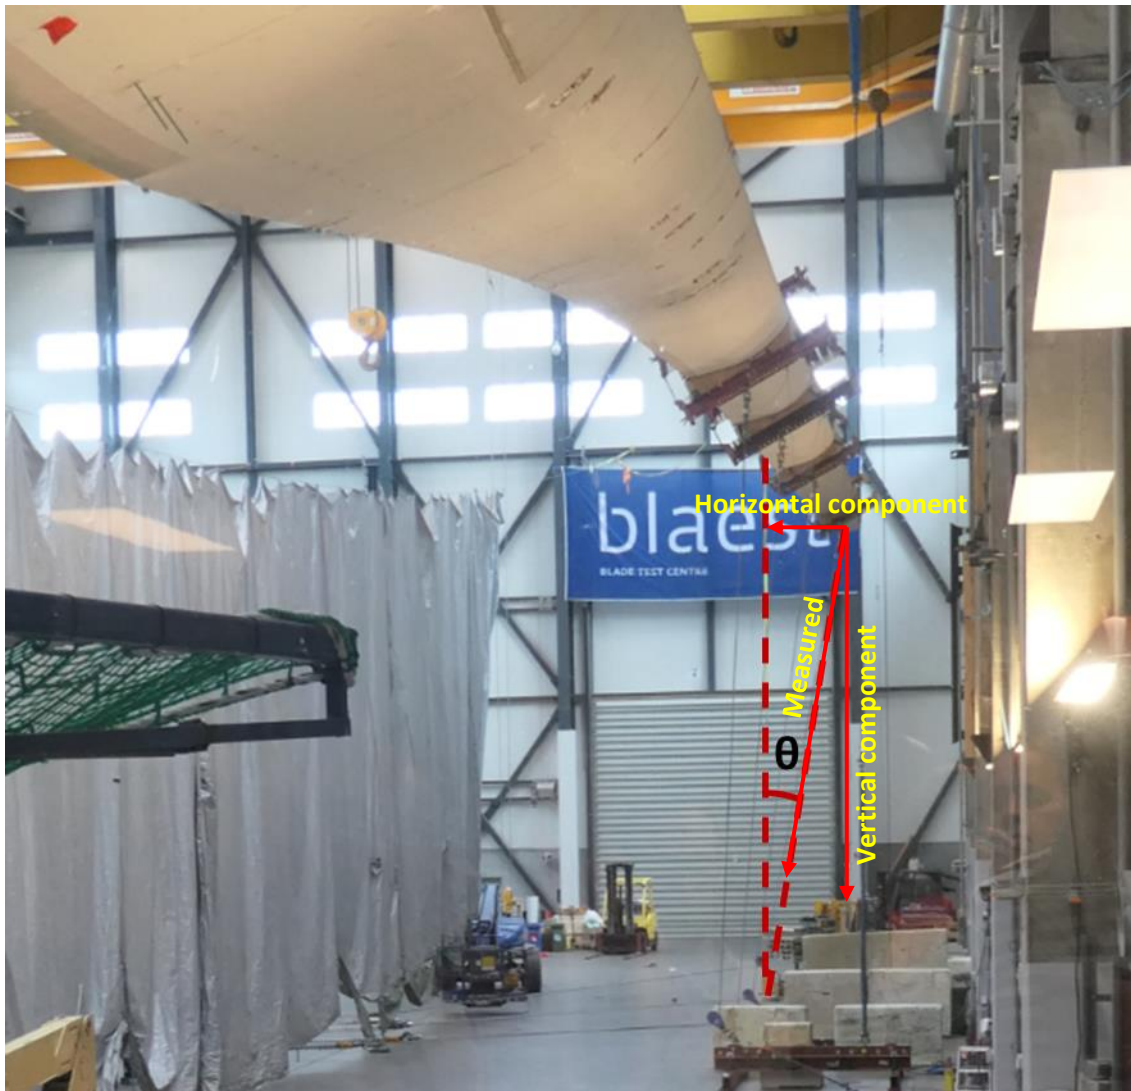
Figure 176: Blade deflection under loading

In order to capture the global deflection of the blade three different sections were chosen as reference points. The blade tends to deflect towards the floor but also sideways due to the combined load configuration. This is better visualized through Figure 176 in Appendix A. In addition, the deflection is measured using draw-wire displacement sensors which are positioned to be perpendicular on the respective section at 100% load. The positions of the sensors are based on theoretic deflection calculations. The respective sections where the measurement devices were implemented are illustrated in Table 14.
