# INSTRUCTION Blade Repair

# 0 | INTRODUCTION

The purpose of this document is to communicate the minimum requirements and documentation for blade repairs.

Bladena, Vattenfall, EON, Statkraft, ENGIE & KIRT x THOMSEN  
in EUDP Project LEX (2014-16) and EUDP Project RATZ (2016-18)

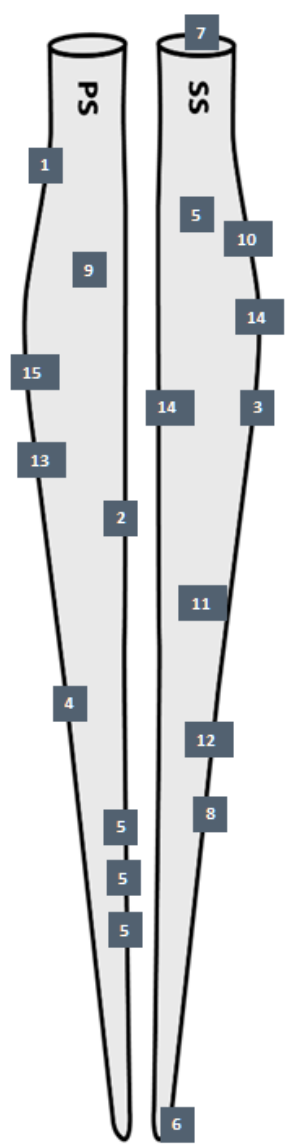
### DAMAGE OVERVIEW

In the section “Damage Overview” is an overview figure of the blade showing PS and SS. Next to the figure is a table where all damages must be listed by damage number and given a damage category depending on the damage. The number boxes can be moved out on the blade figure by dragging to show in which area the damage appear on the blade. Make copies of the boxes if more are needed.

DAMAGE No.	CATEGORY
1	2
2	1
3	5
4	5
5	5
6	3
7	4
8	2
9	2
10	2
11	2
12	1
13	1
14	5
15	3

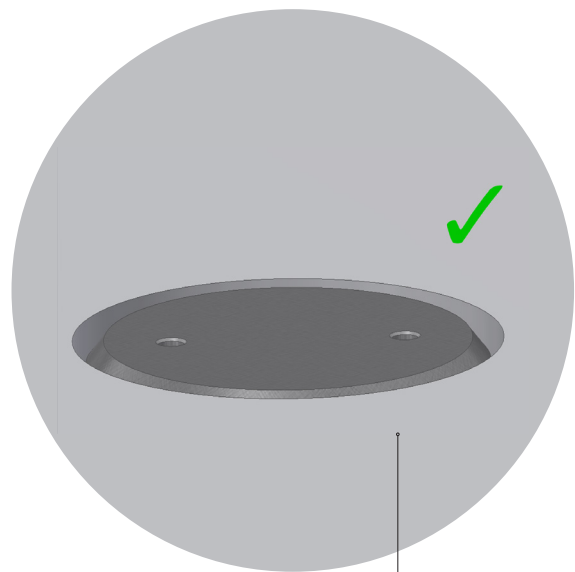
Check that the blade surface 1.5mm from the conical part of the receptor, also check that the receptor is aligned with the blade surface (see figures below)

**Receptor:** The receptor must have a maximum outward offset of 2mm from the blade surface.
